## Remedial Design of An Earth Dam – 20 Years later

**ABSTRACT:** This paper is a sequel to an earlier paper presented by the authors at the 1992 “Stability and Performance of Slopes and Embankments-II” Conference. The original paper described the failure of the upstream slope of a 13.7 m (45 ft) high earth dam in eastern Ohio. The dam was constructed in 1983 and 1984 and the upstream slope failed upon completion of construction, prior to first filling. Subsurface explorations and monitoring identified the failure surface and revealed that the upstream slope continued to creep. A remedial design was developed that included an earthen berm to buttress the upstream slope. The analyses for the design of the stabilizing berm included laboratory creep tests to establish the appropriate level of stress to include for the portion of the failure surface that remained in place. A stress level was selected with the goal of little or no creep movement during operation.

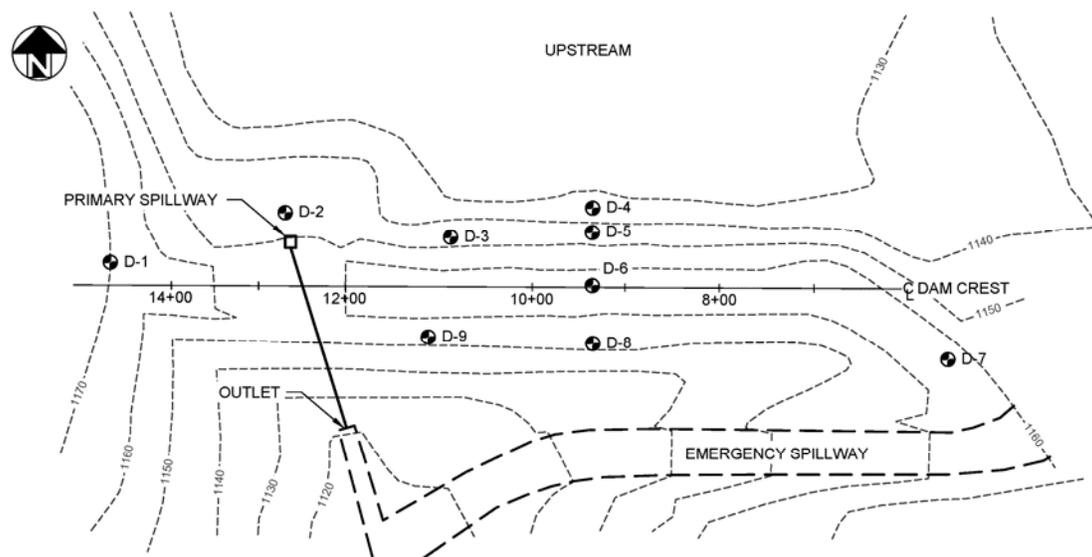
**Figure 1. Site plan prior to remediation**

A crack developed along the length of the crest immediately after construction and prior to first filling. The upstream slope moved downward and away from the rest of the dam resulting in a scarp that was 0.3 to 0.6 m (1 to 2 ft) high in January 1985, 0.9 to 1.2 m (3 to 4 ft) high in July 1985 and 1.5 to 1.8 m (5 to 6 ft) high by the summer of 1986. Shortly after the slope movements were noted, a soil and rock fill berm was placed upstream of the primary spillway tower and the crest was lowered in this area to limit damage to the structure. Figure 1 shows the configuration of the dam and instrumentation that was installed to study the slope failure.

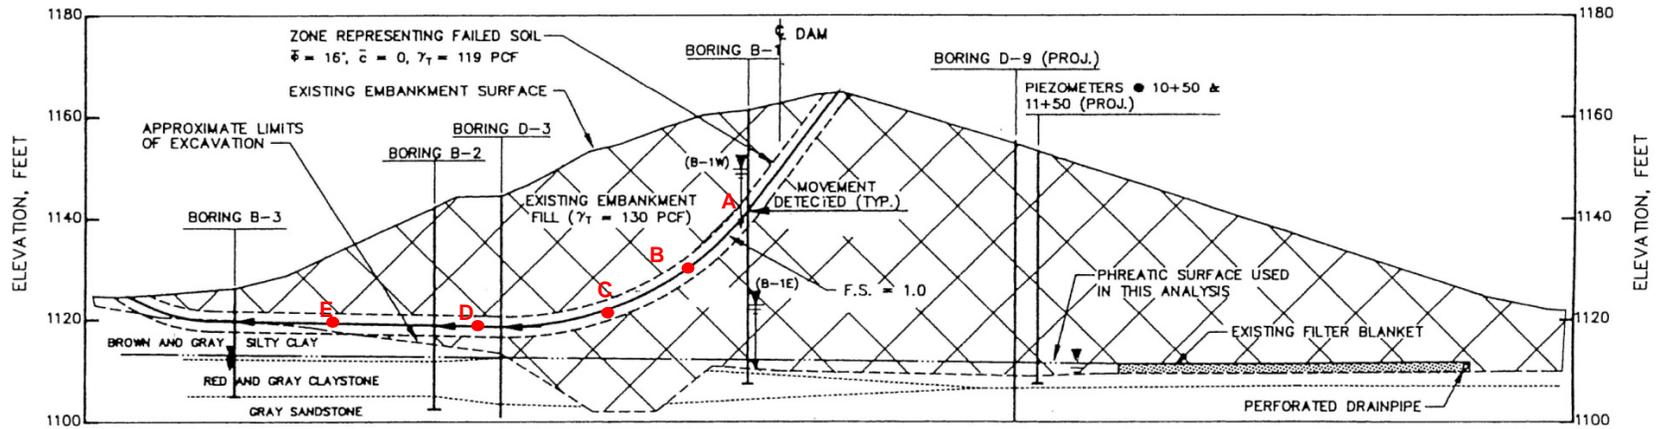
Figure 2. Cross section prior to remediation

As shown on Figure 2, inclinometer measurements indicated that movement was continuing to occur along a surface that extended from near the base of the dam up through the embankment to the crest. The lower, nearly level portion of the failure surface, (approx. El 1120) corresponded approximately to the elevation of fill placement during the shutdown for the 1983-1984 winter.

Slope stability analyses were completed for the existing conditions using the computer program STABL2. The results indicated that a factor of safety of unity corresponds to a friction angle of 16 degrees along the failure surface. This friction angle is less than the residual friction angles measured in direct shear tests on soil samples from in or near the slide zone (17 to 30 degrees). It was hypothesized that the soils along the failure surface were deforming at stress levels below the peak levels measured in the direct shear tests. The concept of deformation occurring at stress levels below the peak values measured in short duration tests has been discussed by many researchers including Mitchell (1976) and Tavenas and Leroueil (1981).

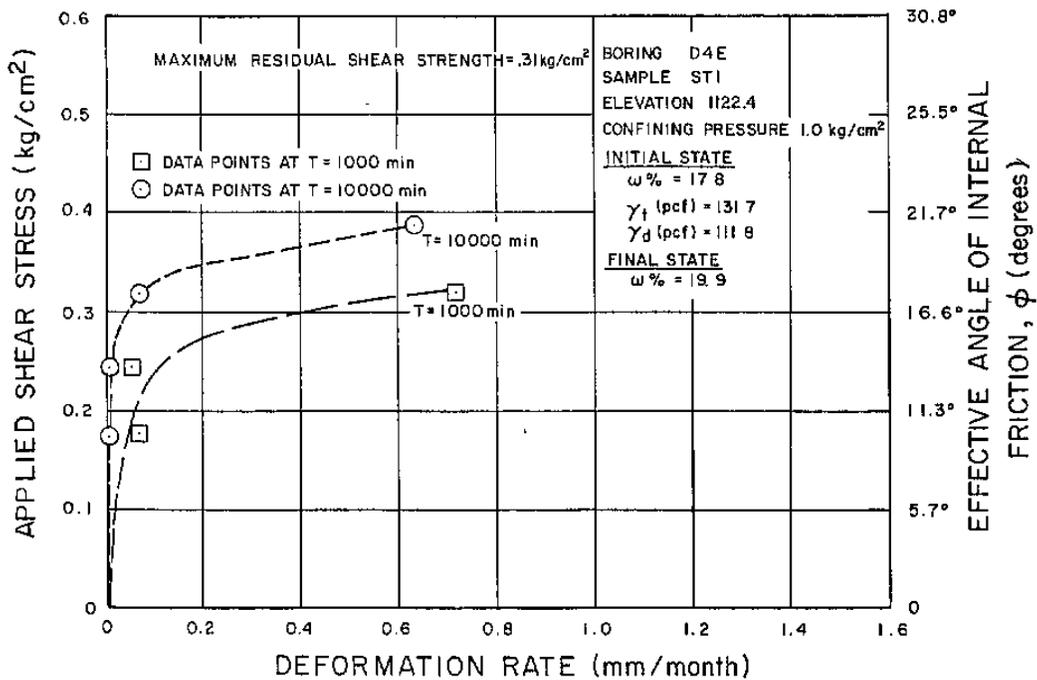
Figure 3. Typical plot of stress controlled test results

Constant stress direct shear tests were completed to characterize the creep behavior of the soils along the failure surface. The purpose of the tests was to explain the ongoing creep movements and develop an appropriate friction angle for the portion of the failure surface that would remain in place in the remedial design. The test procedures and the results are described in the previous paper. The results for all of the samples showed a significant increase in deformation rate when the shear stress exceeded a friction angle of about 16 degrees. Figure 3 is a typical plot of the results.

The close agreement between the back-calculated friction angle and the stress level at which creep movement initiated in the constant stress tests, supported the hypothesis that the soils along the failure surface were deforming at a stress level below the residual shear strength.

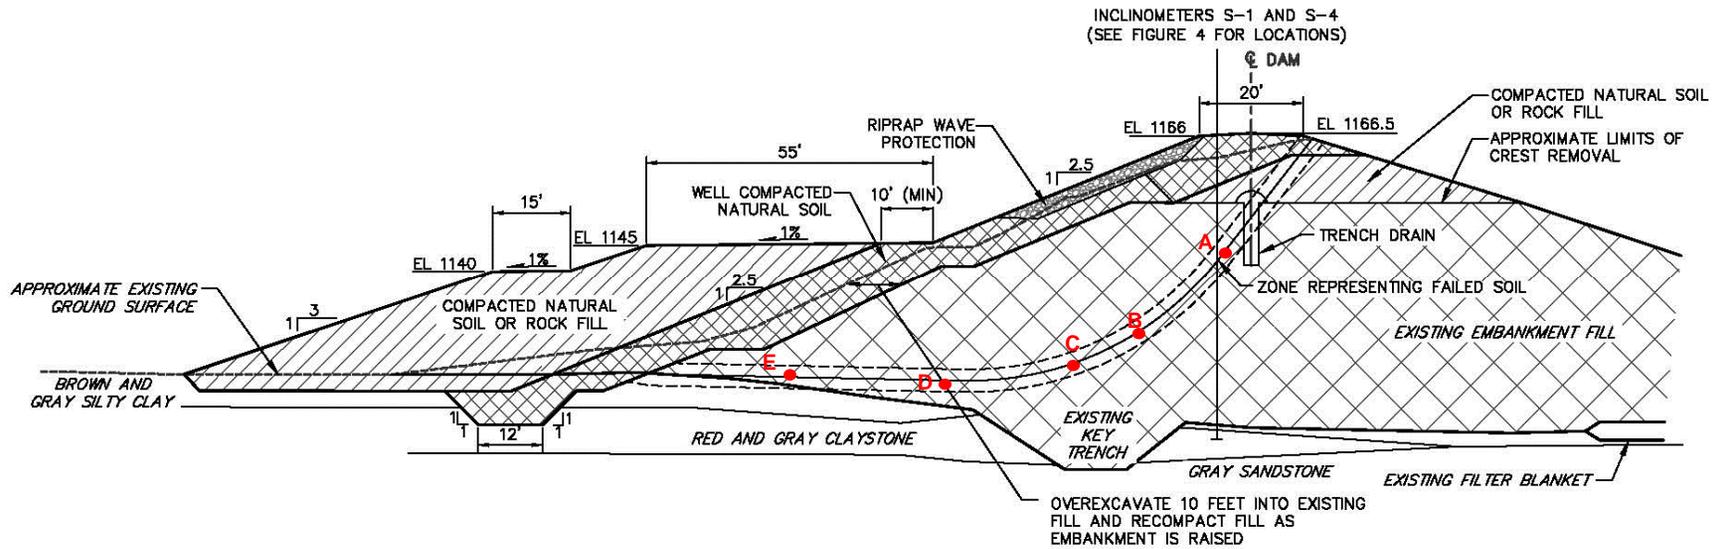
Figure 5. Cross section of remedial design

The analyses included a factor of safety of at least 1.5, therefore it was expected that the shear stress on the failure surface would be less than that represented by a friction angle of 14 degrees. At this low stress level, no significant additional movement was expected after the remedial design was constructed.

The buttress configuration was based on slope stability analyses. Figure 5 is a cross section near the middle of the dam showing the buttress configuration. In order to restrict creep movement after remedial construction, the design analyses used a friction angle of 14 degrees to represent the portion of the failure surface that was left in place. As shown on Figure 3, little or no creep movement was observed in the constant stress tests at this level of shear stress. The previous paper describes the other material properties used in the analyses.

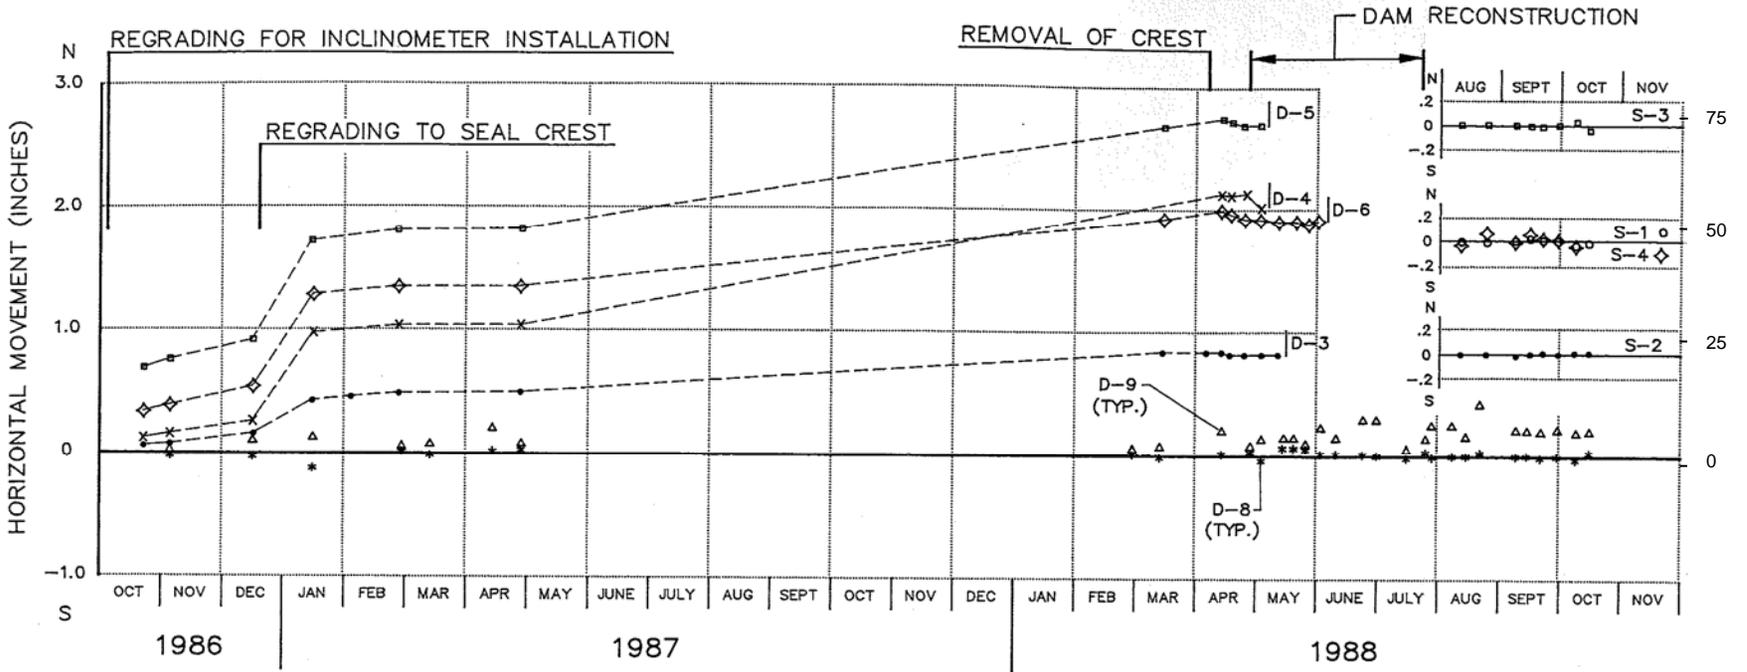
Figure 7. Inclinometer monitoring through design and remedial construction

The upstream slope of the Boy Scout Dam has been monitored since 1986 after the failure was observed, through remedial design and construction and for the 20 plus years since remedial construction. Figure 7 is a plot of the inclinometer data through remedial design and construction, reflecting movement at a depth corresponding to the maximum deformation and at the approximate shear plane. The locations of the inclinometers that were monitored during the remedial design phase and for the initial portion of construction are shown on Figure 1. Inclinometers D-4, D-5 and D-6 are located near the center of the dam and show that during the remedial design the upstream slope was creeping at a rate of about 2.5 mm (0.1 in) horizontally per month. It was also observed that minor regrading of the slope and other factors such as heavy rainfall increased the rate of movement.

During remedial construction, the upper 3 to 4.5 m (10 to 15 ft) of the crest was removed, the buttress was constructed and then the crest was replaced. Monitoring of the inclinometers was continued through removal of the crest until reconstruction work required their removal. As shown on Figure 7, the creep movements stopped after the crest was removed.

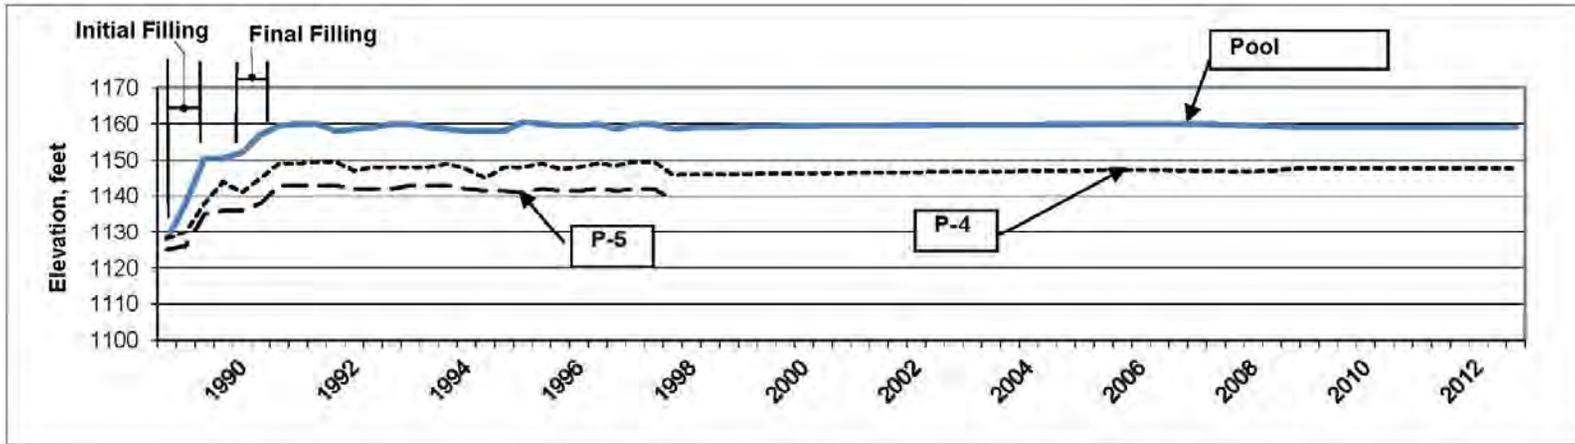
Figure 8a. Reservoir pool level and piezometer measurements

Figure 8 includes two graphs, one showing the pool level and the piezometric levels at pneumatic piezometers P-4 and P-5 (see Figures 4 and 5 for location) and the other showing horizontal movement at inclinometers S-1 and S-4, at a depth corresponding to the position of maximum displacement and the approximate original shear plane.

The final normal pool is El. 1160 however the reservoir was initially raised to El. 1150 and remained there for about 6 months. As the reservoir filled, the piezometric levels in P-4 and P-5 increased and movement was observed in both S-1 and S-4.

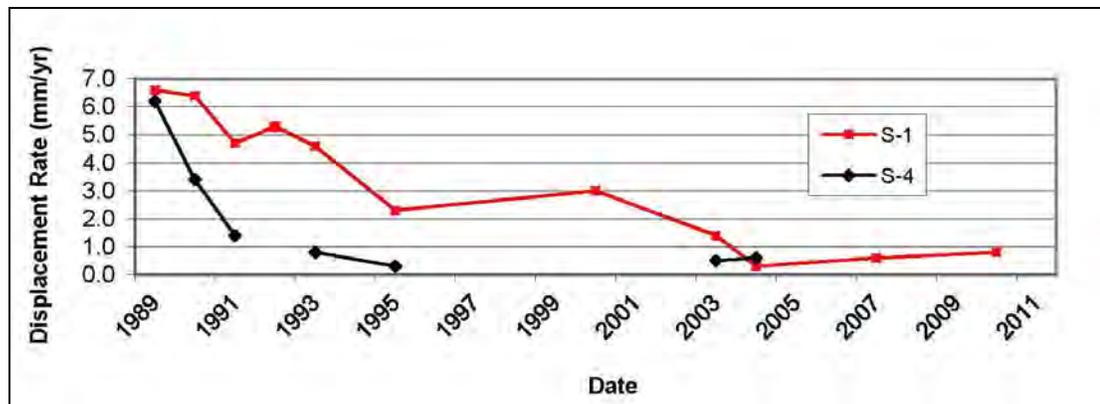
**Figure 9. Rate of post remedial construction inclinometer movement**

Figure 9 is a plot of the rate of movement with time for S-1 and S-4 and shows that during initial filling, the horizontal movement was at a rate of about 6.3 mm (0.25 in) per year. Once the reservoir level reached El. 1150, movement in both inclinometers appeared to diminish. After 6 months, the reservoir was raised to its final elevation at El. 1160. As the reservoir level increased, horizontal movements were again detected, at post-remedial construction rates, in both inclinometers. The movement in S-4 subsided a few months after the reservoir reached its maximum level and very little movement has been observed in this inclinometer since the reservoir reached its maximum level.

Horizontal movement continued at inclinometer S-1 for about 20 years after the reservoir reached its maximum pool level. As shown on Figure 9, the rate of movement in S-1 gradually decreased from about 6.3 mm (0.25 in) per year in 1991 to less than 1.5 mm (.05 in) per year in 2010. This extended period of movement was not anticipated given the remedial design stress levels estimated based on limit equilibrium analyses, and resulted in questions about the design assumptions and the basis for establishing the expected performance of the dam.

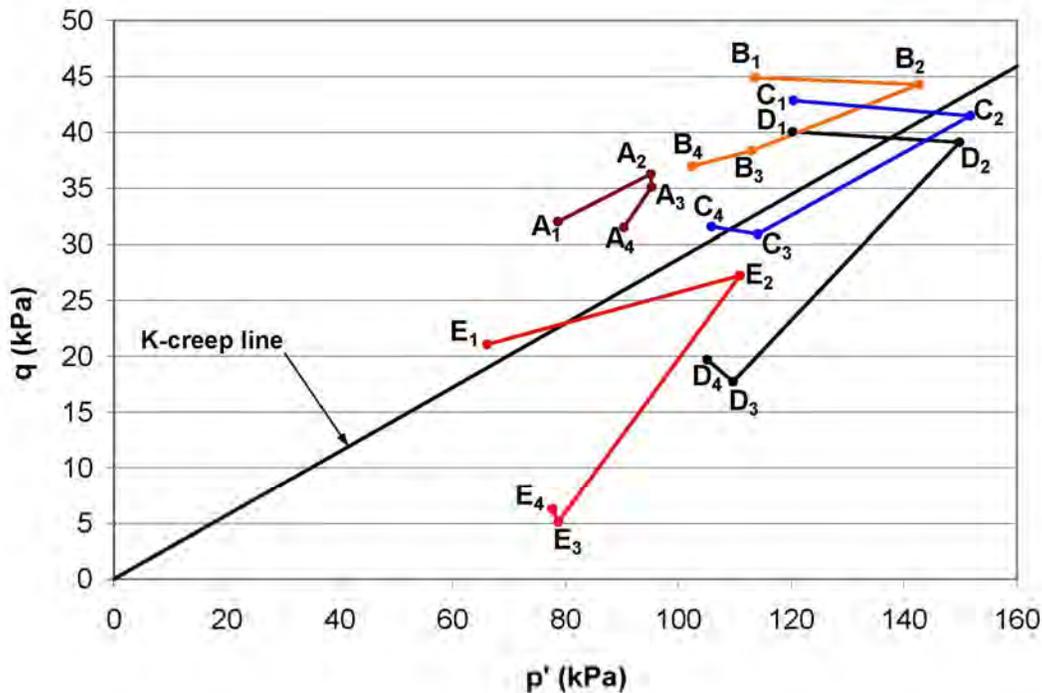
**Figure 11. Stress paths for points on failure surface**

The stress paths for conditions 1 through 4 at points A through E are also plotted on Figure 11. The stresses at all points plot above the  $K_{creep}$  line for the existing conditions (Case 1), suggesting that movement would be occurring at this state of stress. This is consistent with the observations of creep movements for the existing conditions.

After the buttress is constructed and the top is replaced (Case 2) the stress paths shift to the right. The stress conditions at point A remain above the  $K_{creep}$  line while the stresses at B point move closer to the  $K_{creep}$  line and the stress conditions at points C, D and E move below the  $K_{creep}$  line. The stresses suggest that creep movements would be occurring on the upper portion of the failure surface but not along the lower portion of the failure surface. The inclinometer measurements after construction and prior to filling did not show horizontal movement (Figure 7). Either creep movements were not occurring at this point or they were too small to be detected during the short time between construction and filling the lake.

As the reservoir is filled and the upstream slope is saturated (Case 3)  $p'$  and  $q$  both decrease and the stress path shifts down and to the left. The reduction in  $q$  is consistent with the observations of Bishop and Bjerrum (1960) that there is a reduction in shear stress upon filling due to the stabilizing effect of the water pressure. This is accompanied by a reduction in effective stress,  $p'$ , (and shear resistance) due to saturation of the upstream slope. The net effect is to either improve or reduce the stability depending on the point in question and the geometry of the slope. The stress conditions at points on the upper portion of the failure surface become less favorable upon saturation while those on the lower portion become more favorable. Point A, on the upper portion of the failure surface, stays above the  $K_{creep}$  line and Point B, also on the upper failure surface, moves above the  $K_{creep}$  line as the upstream slope becomes saturated. Point C stays below the  $K_{creep}$  line but moves closer to it. Points on the lower portion of the failure surface (D and E) appear to become more stable (i.e., move away from the  $K_{creep}$  line). The movement of the stress paths to less favorable positions for points on the upper portion of the failure surface could explain the continued deformation detected in the inclinometers in the upper portion of the failure surface upon saturation of the upstream slope.

A time passes (Case 3 to 4), there is a stress transfer from the soil in the upper portion of the failure surface to the soil in the lower portion of the failure surface. The shear stress at points A and B is reduced while at points C, D and E it increases. This results in a reduction in the creep rate of the upper soils and coincides with the condition that the dam is approaching some 20 years after remedial construction is complete.
