North Forest Road Slumping into Ellicott Creek

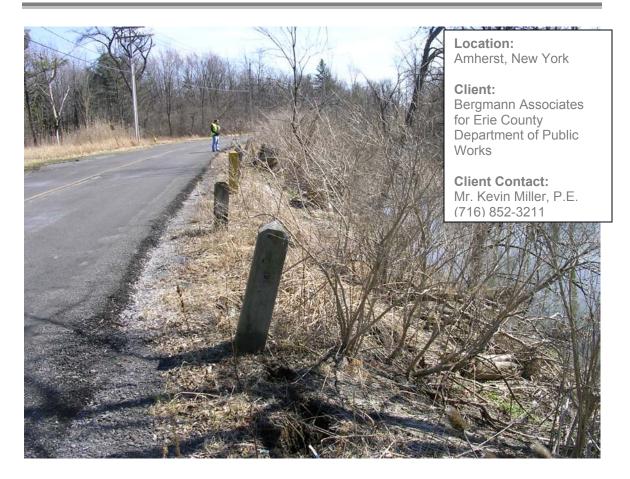
The ground between North Forest Road and Ellicott Creek has been slumping into the creek, causing the Erie County Department of Public Works to frequently repave the road. The DPW elected to reconstruct the highway and hired Bergmann Associates to design the reconstruction. Bergmann Associates engaged MMCE to explore the cause of the slumping creek banks so that this condition could be addressed as part of the reconstruction project.

MMCE drilled test borings along North Forest Road and laboratory tested soil samples from the borings. The data showed that groundwater flows towards Ellicott Creek from the land on the opposite side of the road, causing the creek banks to slough from the seepage forces. The borings also showed that the road had an insufficient subbase thickness, which caused the pavement to crack.

MMCE recommended including subsurface drainage as part of the reconstruction project and provided detailed sketches to assist with the design of these structures.
