PROJECT DESCRIPTION

County Road 76 – Slope Failure

Location:
New Albion, New York

Client:
Cattaraugus County
Department of Public Works

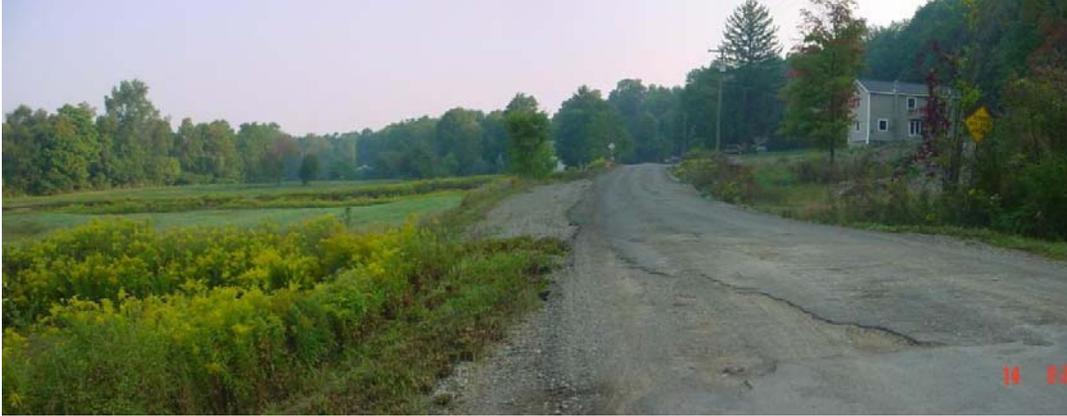
View of Slope Failure Looking North

The Cattaraugus County Department of Public Works (CCDPW) has identified a landslide affecting County Road (CR) 76 (Lovers Lane Road) in the Town of New Albion, New York. The slide extends from an unnamed tributary to the South Branch of Cattaraugus Creek, across the road, and into property located on the east side of the road.

Based on conversations with local residents, aerial photographs dating back to the 1950's, and discussions with county officials, the slide began in the mid-1990's and has been moving since. A house located at 7334 Lovers Lane Road (right side of photo) incurred significant structural damage until it was purchased by the Federal Emergency Management Agency (FEMA) and demolished in 2006. The asphalt road within the slide zone has been damaged due to the movement. The asphalt has cracked and been resurfaced several times since the slide began.

MMCE made test borings and installed inclinometers and vibrating wire piezometers into the moving slope. The subsurface conditions consist of a sand and gravel layer underlain by a clayey silt deposit above a glacial till layer.

Our observations over a period of 8 months indicate the groundwater level in the till is confined by the clayey silt layer and is above the ground surface. The confined water pressure is pushing on the overlying soil causing it to move toward the creek. This is confirmed by our observation that the rate of movement of the slope is closely related to the water pressure in the till.

We are currently working with Cattaraugus County to install relief wells extending into the till and rock to lower the piezometric head in the till to reduce the slope movement.
