## Remedial Design of An Earth Dam – 20 Years later

**ABSTRACT:** This paper is a sequel to an earlier paper presented by the authors at the 1992 “Stability and Performance of Slopes and Embankments-II” Conference. The original paper described the failure of the upstream slope of a 13.7 m (45 ft) high earth dam in eastern Ohio. The dam was constructed in 1983 and 1984 and the upstream slope failed upon completion of construction, prior to first filling. Subsurface explorations and monitoring identified the failure surface and revealed that the upstream slope continued to creep. A remedial design was developed that included an earthen berm to buttress the upstream slope. The analyses for the design of the stabilizing berm included laboratory creep tests to establish the appropriate level of stress to include for the portion of the failure surface that remained in place. A stress level was selected with the goal of little or no creep movement during operation.

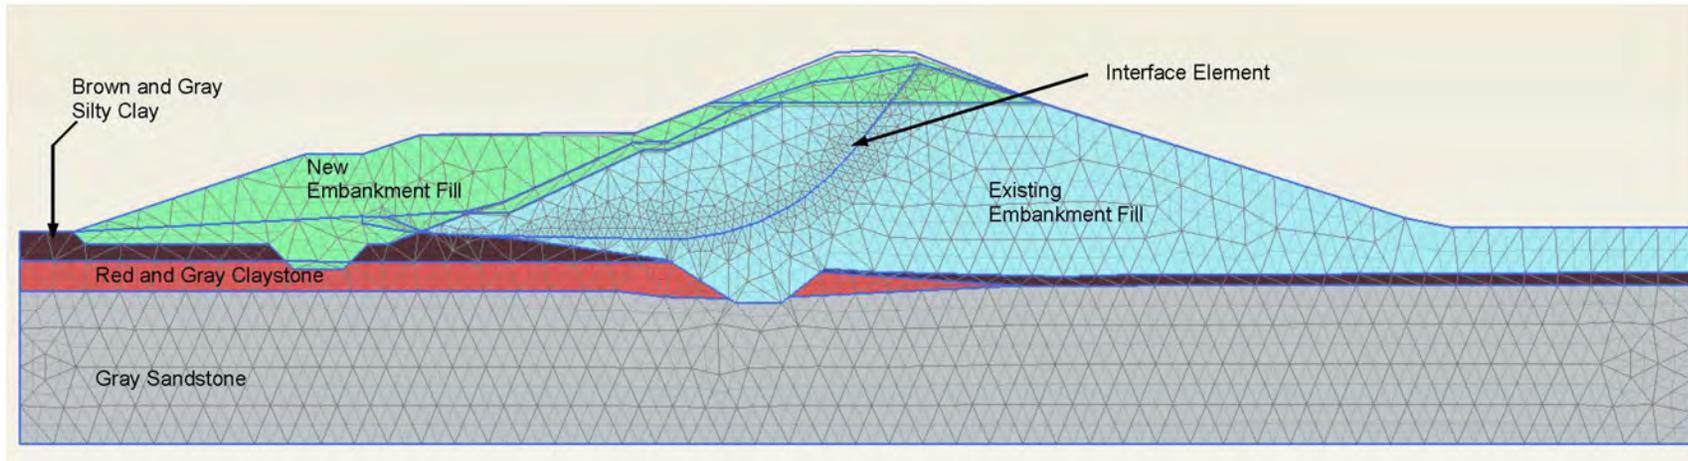
**Figure 10a. Finite element mesh**

To help explain the observed long term movement at the Boy Scout Dam, the Plaxis (2011) two dimensional finite element computer program was used to estimate the stress conditions at selected points on the failure surface. The cross-sections shown in Figure 2 and Figure 5 were used to develop a plane strain finite element model. The Soft Soil Creep soil model along with an interface element was used to model the existing embankment soil and the known failure surface through the embankment fill. The Mohr-Coulomb soil model was used for the remaining soil layers. All layers were modeled as drained behavior types. Parameters selected for the soil layers, including the embankment fill, were based on the subsurface investigations completed during the remedial design of the dam. Parameters for the underlying rock layers were based on typical values for similar material. Figure 10 shows the finite element grid and the input parameters for the model.
