## PROJECT DESCRIPTION

### *Zoar Valley Road – Slope Remediation*

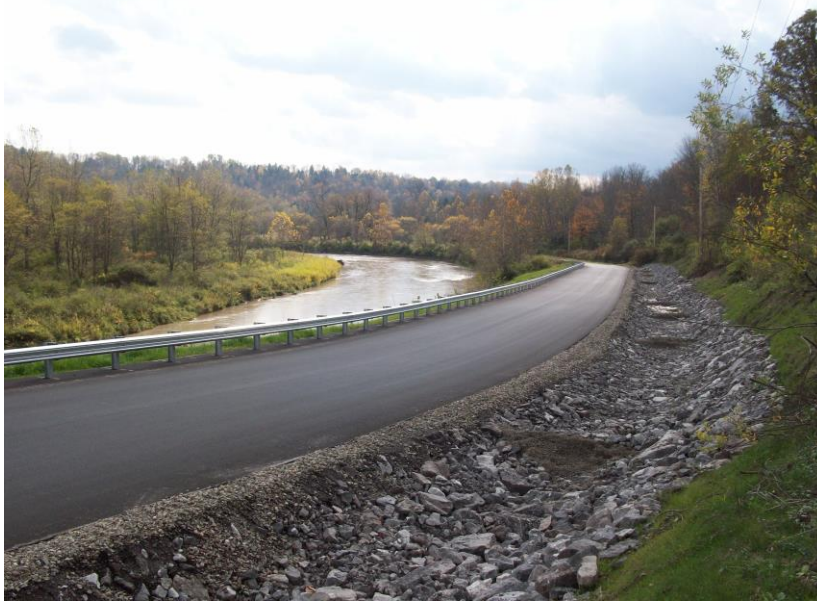
#### ***Completed road surface and drainage***

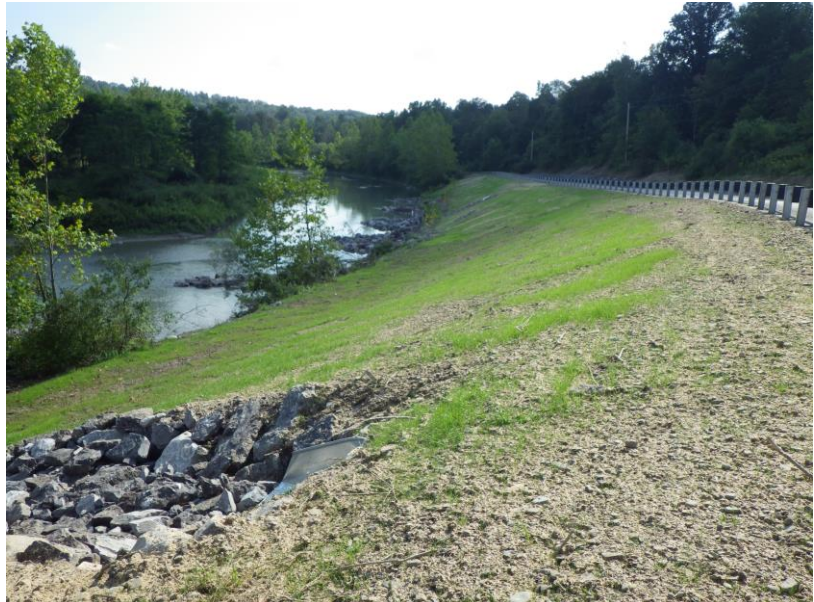
#### ***Road embankment and bendway weirs***

The remedial design included removing portions of the soft clay, installing subsurface drainage trenches, installing a geosynthetic reinforced slope, improved surface drainage and re-directive measures in Cattaraugus Creek to limit erosive forces on the slope beneath the roadway. The re-directive measures include a series of bendway weirs to guide the flow around the bend and to maintain the higher flows away from the bank.
